## **Renovation of a house in Morangis - Summary report of environmental studies**

**VELUX - LIVING PLACES - RENOVATION**

Artelia has been commissioned as part of the "Living Places Renovation" project initiated by VELUX France. The aim of this project is to experiment with renovation concepts in real-life situations, in order to improve the energy performance and interior comfort of existing homes, particularly single-family homes with convertible attic space.

The renovation of a house in Morangis is therefore part of this project, as a pilot.

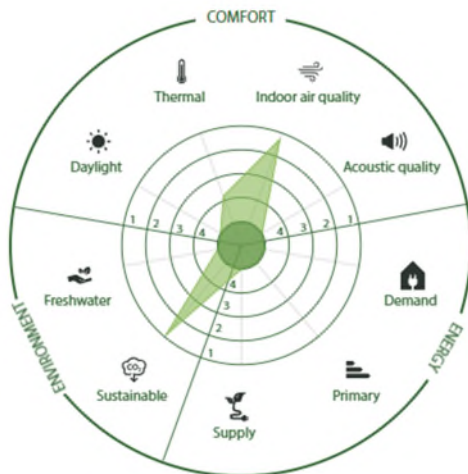
Morangis - Before works

The results in the form of radars were extracted directly from the online site and can be seen below:
