# House renovation in Morangis – Design process and results

## Living Places 2.0 - Renovation

ATELIA | VELUX | 12/05/2025 | 10820835

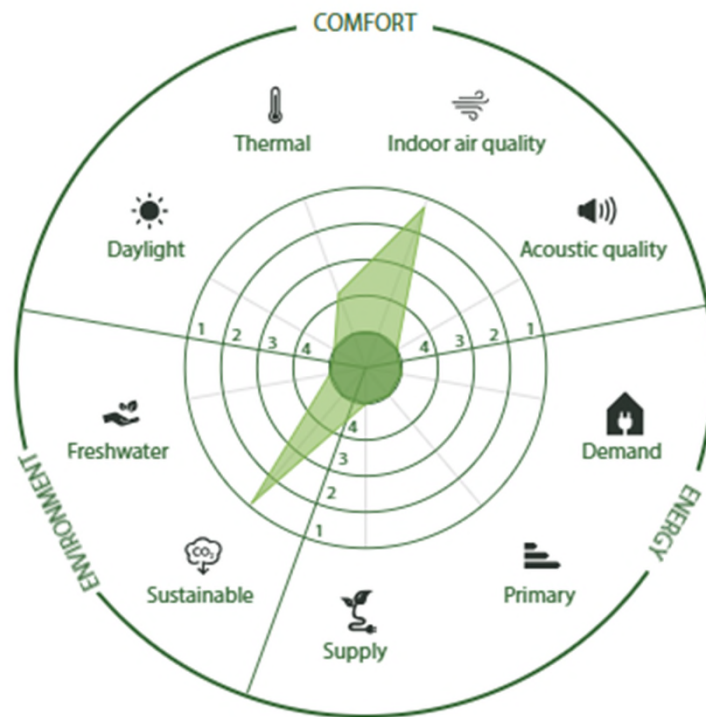
Morangis – before works

# Active House Radar

Initial house results compared to planned works

| | Before works | | After works | | |
|---|---|---|---|---|---|
| Daylight | Out | 2,9 | Out | 2,3 ↗ | Attic space added |
| Thermal environment | 3,8 | 3,8 | 1,8 | 1,8 ↗ | Insulation, window changing, natural ventilation |
| Indoor air quality | 1,3 | 1,3 | 1,3 | 1,3 → | <i>See specific part</i> |
| Acoustic quality | Out | 2,4 | Out | 2,1 | Window changing and external insulation |
| Energy demand | Out | Out | 1,3 | 1,3 ↗ | Insulation and heating system modification |
